Borough of Beaver  
Beaver Municipal Swimming Pool  
Beaver County, Pennsylvania

Facility Site Observation Conditions Report

Prepared by:  
Aquatic Facility Design, Inc.  
&  
Environmental Planning and Design, LLC.

APRIL 2020

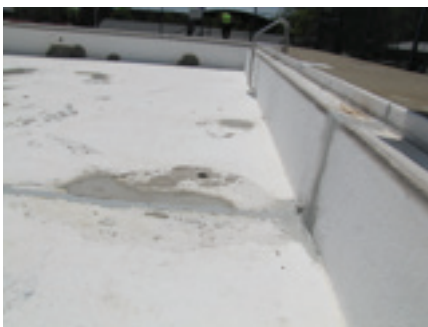
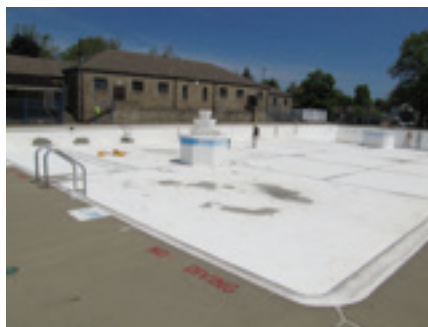
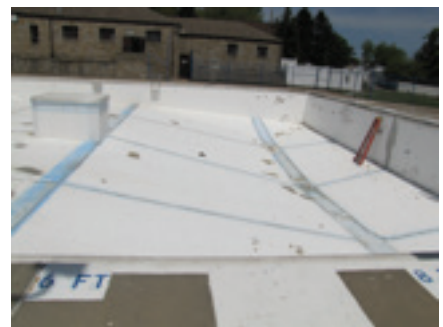
1. The Main Pool is in a state of advanced structural decay, with the main surfaces in which patrons come into contact being a network of patch upon patch. See photos taken 5/17/2011 Fig. 6, 7, 8.

The entire structure is rotten and spalled beyond the point of repair. There is no solid surface left on which to repair.

Continued patching, a vinyl liner, or a fiberglass overlay as remediations have all been ruled out. There is no known repair method available for this pool to insure a reasonable standard of safety or stable and sanitary conditions for the public.

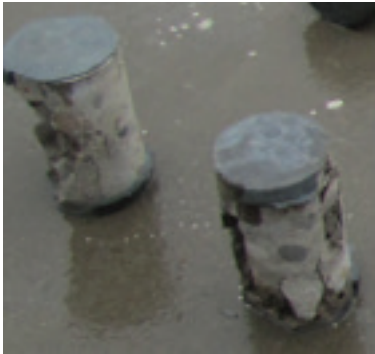
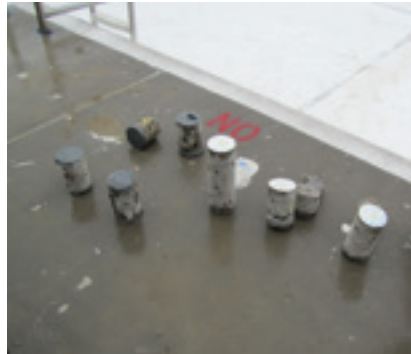
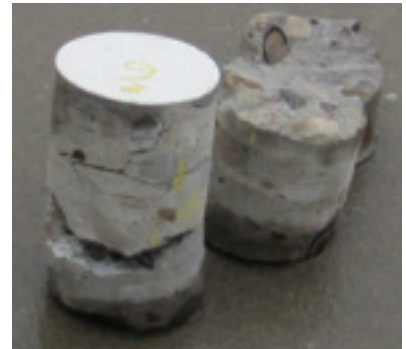
See core boring samples taken 5/3/2011 Fig. 9, 10, 11. Which revealed a fractured and weakened structure.

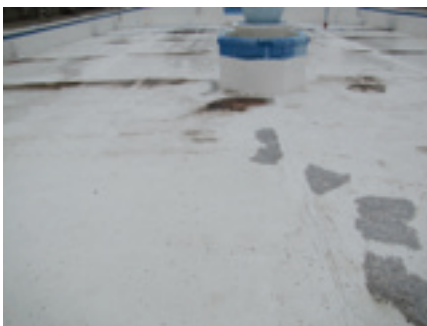
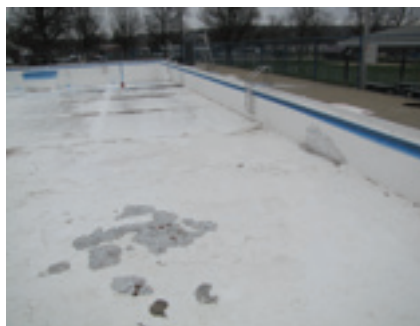
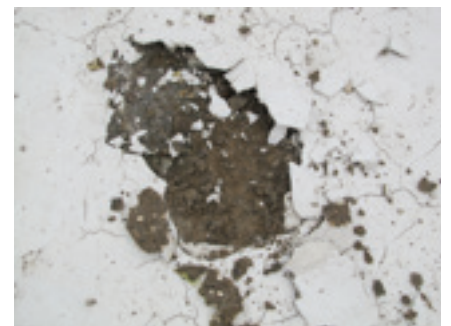
See photos taken 3/27/2020 Fig. 12, 13, 14.

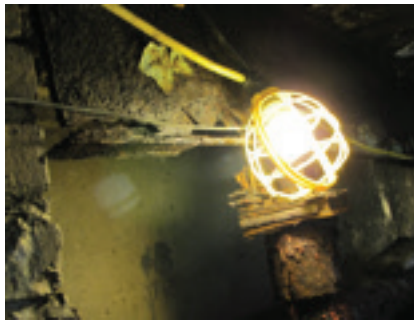
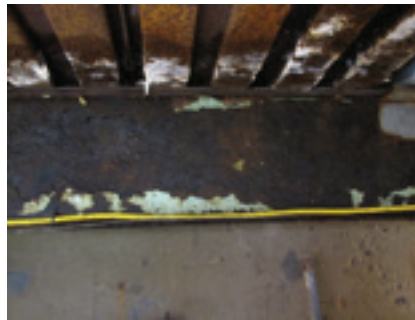
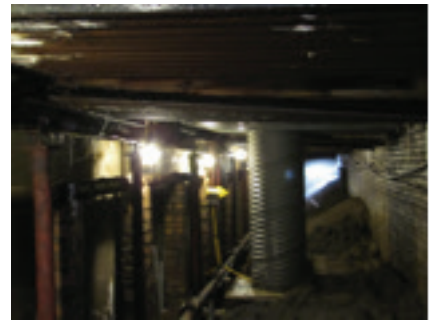
Additionally, the supports for the hollow access around the pool for access to the piping are rotted to the extent that entry is unsafe and a collapse of the deck could occur. See photos from 3/27/2020 Fig. 15, 16, 17.

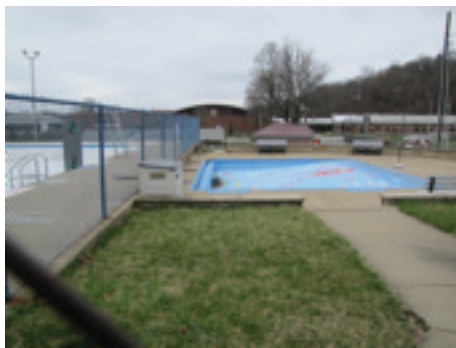
Figure 18

2. The Wading Pool although structurally sound is deeper than the 18 inch maximum water depth allowed by code, See Fig. 18. It also has a milk crate acting as a drain cover which is a highly dangerous entrapment hazard for children and is in violation of the Federal Virginia Graeme Baker Pool & Spa Safety Act. See Fig. 19

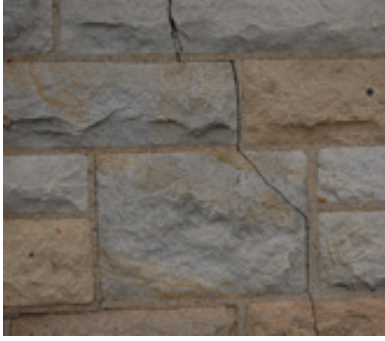
1. Minor cracking was observed above some of the door and window lintels which is common for the age of the building. Minor cracks were also observed at the south corners of the building indicating minor building settlement.
2. Separation of building facade from concrete structure occurs near stairs leading to the pool deck. The separation of the veneer from the structure is problematic because this is an opportunity for moisture to get in. Over time, the accumulated moisture and the freeze/ thaw cycle will cause the veneer to release itself from the structure. (See figures 3-6 below.)

Figure 3: Cracking Mortar

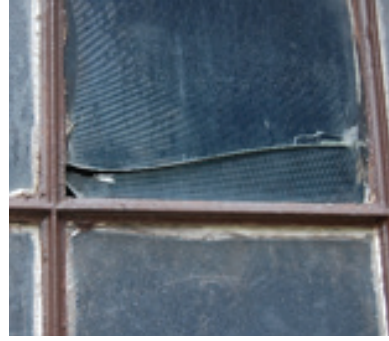
Figure 4: Cracked leaded glass

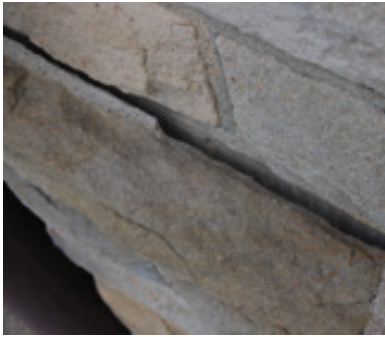
Figure 5: Separation of mortar from concrete structure

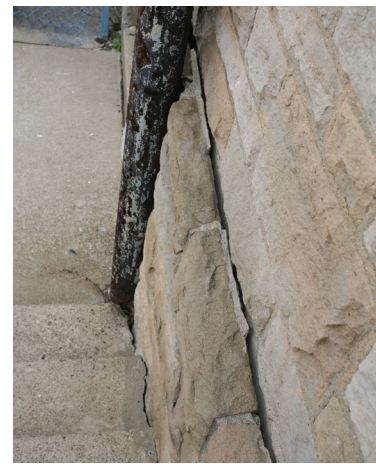
Figure 6: Separation of veneer from concrete base

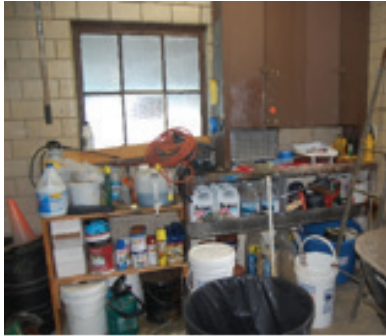
3. There are spatial issues with how the building is utilized. At present there is inadequate storage for cleaning supplies and pool chemicals. Pool chemicals and cleaning supplies are stored throughout the building and not in a centralized location. While these items are secure in the sense that they are not accessible to the general public, the combination of caustic items that do not have their own designated storage space is not a good practice. (See figures 7-8 below.)

Figure 7: Storage Area

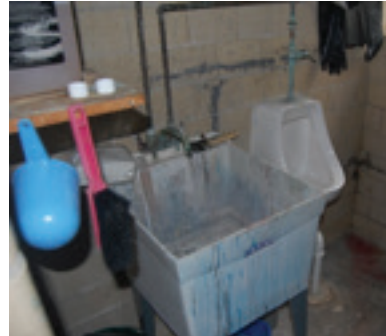
Figure 8: Urinal in storage area

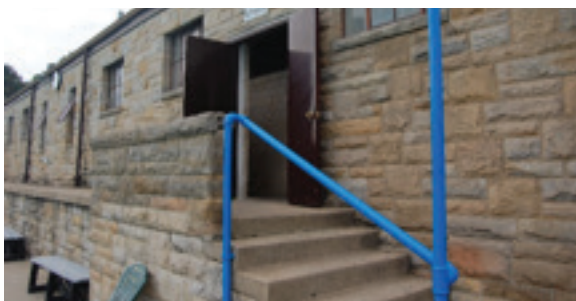
4. There is inadequate areas for lifeguards to take breaks during their duties. Lifeguards share the locker area with the cramped management office.
5. Currently there is no space to expand for other programming like: birthday parties, a fitness area, or other social space. The number of partitioning interior walls, known as demising walls, in the building would make reconfiguration of the building to accommodate this programming while maintaining the bathhouse programming challenging.
6. There is a large elevation difference between the pool deck and the bathhouse main-floor which inhibits someone with physical mobility issues to easily move about. This makes entry to the bathhouse inaccessible for people with mobility issues. Given the amount of elevation difference improved accessibility can only be resolved with an elevator, chair lift, or ramp.

Figure 9: Large change in elevation from pool deck to bathhouse

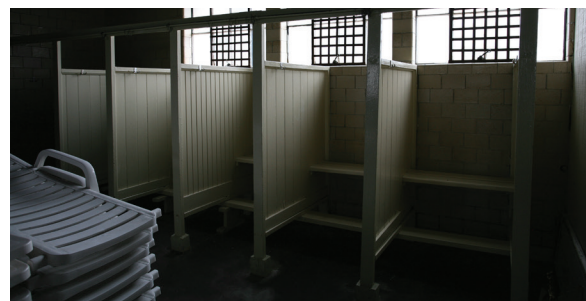
Figure 10: Area for privacy screens

7. Currently the existing bathhouse does not offer a privacy screen changing area in both the male and female locker rooms for patrons who wish to have more privacy (See Figure 10 above.)
8. Given that there is a lot of importance placed on being architecturally true to the period of the Existing Bathhouse, the current aluminum garage door opening to the vestibule of the building, while tastefully executed, does not reflect this desire.

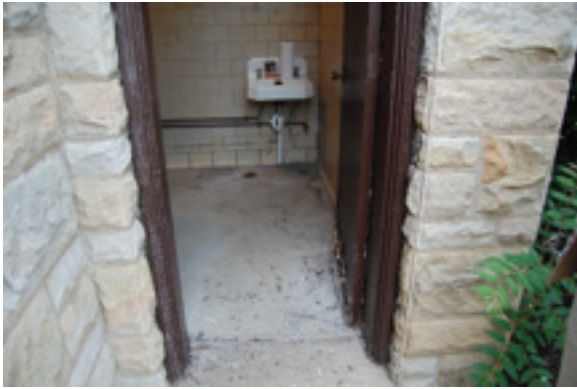
1. All doorway openings provided along the ADA accessible route and restrooms must have 32" clear space thru the doorway opening. This means the doors need to be changed to a 36" wide door to meet this requirement. This will also include the door replacement for access to the men's and women's public restroom areas located on the exterior of the building. The existing 33" and 34" clearance around the showers in the men's and women's locker rooms does not provide the 36" clearance for the ADA accessible route; therefore, the showers will need to be redesigned.
2. Currently there is no drop-off area for patrons to get from a vehicle to the pool. Borough staff say that 40-50% of pool users arrive by car but there is not an ADA ramp or drop-off of any kind to accommodate this.

Figure 10: Width of door not ADA compliant

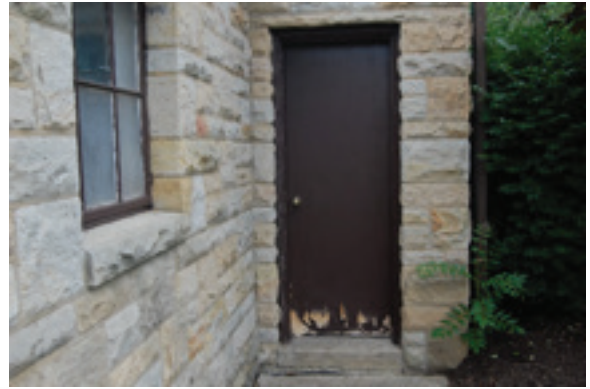
3. Ground surfaces are not ADA compliant: There are two areas of concern, the Men's and Women's exits from the bathhouse and the entrance to the exterior bathrooms.

Figure 11: Ground and floor surfaces are not ADA compliant

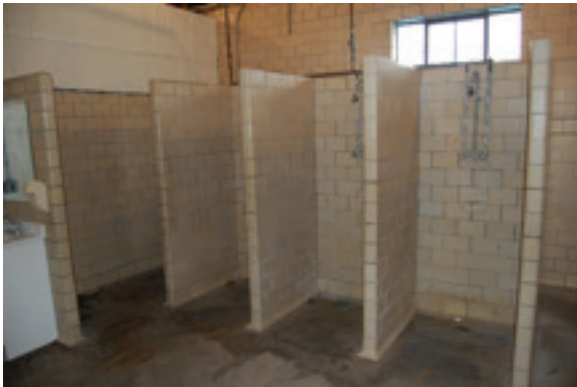
6. There are showers in each of the men's and women's locker room area, although not ADA compliant. The existing rest room in the guard and field house area is too small to convert to an ADA restroom.

Figure 12: Showers not ADA compliant

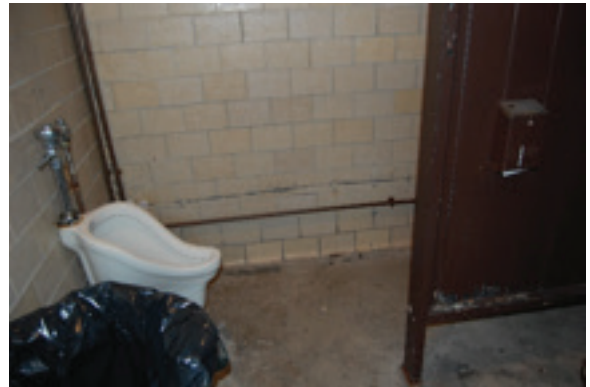
7. Urinals in men's room do not meet ADA requirement. Flush handles and rim height are not appropriate heights.
8. The interior restroom in each locker room should have an ADA compliant stall and meet the other requirements. The exterior men's and women's restroom areas will need to meet this requirement.

Figure 13: Urinal not ADA compliant

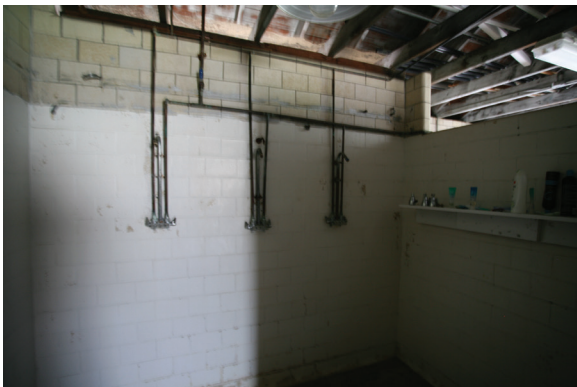
Figure 14: Showers not ADA compliant

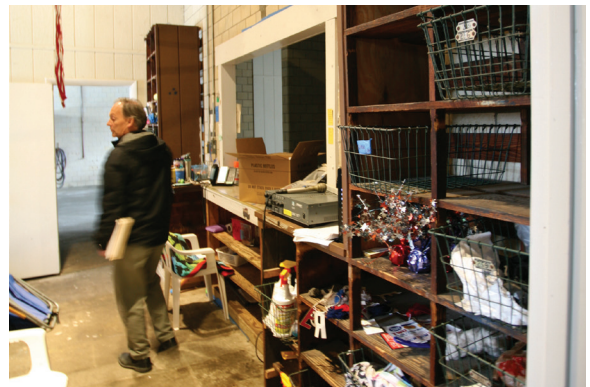
10. Counter height at reception area does not have an appropriate wheelchair height accessible counter.

Figure 15: Counter height not ADA compliant
