Borough of Beaver  
Beaver Municipal Swimming Pool  
Beaver County, Pennsylvania

Facility Site Observation Conditions Report

Prepared by:  
Aquatic Facility Design, Inc.  
&  
Environmental Planning and Design, LLC.

APRIL 2020

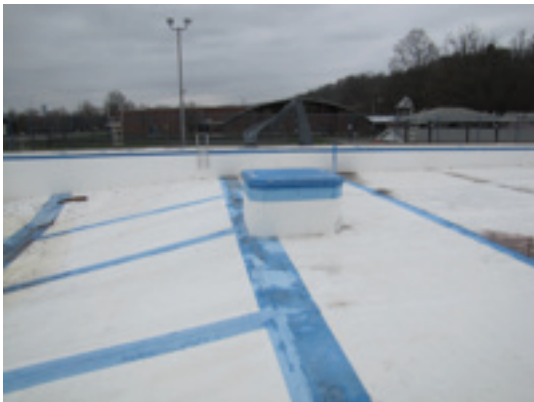
Figure 1

There are no competition style race lanes. A single rope line divides the shallow and deep areas of the pool. See Fig. 1. There is a series of stainless steel ladders for access and fixed in place lifeguard platforms. A poured concrete deck surrounds the pool. A single dive platform is present at the end wall of the deep well. See Fig. 2. No additional play type or other general recreational amenities exist.

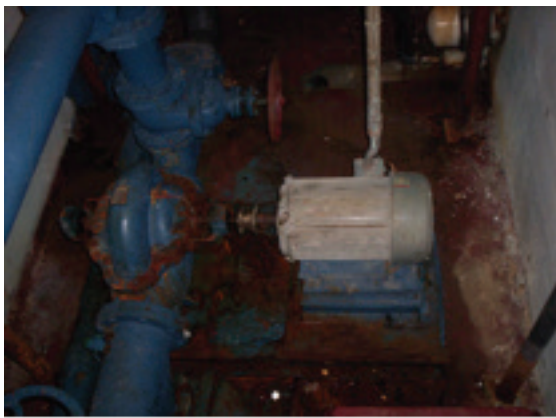
Figure 3

The Main Pool filtration system consists of a gravity fed recirculation pump and motor linked to an on grade vacuum sand filtration system. See Fig. 3. The filter tank is concrete with manual setting controls. The chemical system consists of a Liquid Chlorine system for sanitation. See Fig. 4. The Filtration and Chemical Systems are located within the Bathhouse Building.

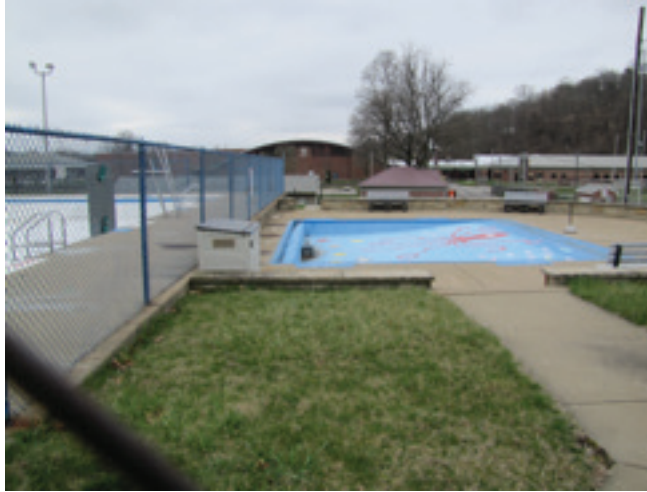
Figure 5

The Wading Pool is believed to have also been constructed in the early 1930's. It is constructed of steel reinforced concrete. It is of a square configuration. The pool consists of approximately 601 sq. ft. of surface area. The pool has an underground recirculation piping system. Underground piping appears to be a combination of PVC and steel composition. A poured concrete deck surrounds the pool. See Fig. 5.

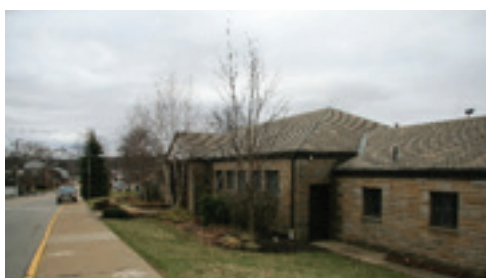
Figure 1: Exterior view of the existing bathhouse

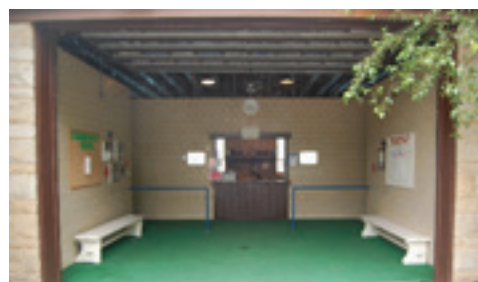
Figure 2: Interior vestibule of the existing bathhouse when roll up door is open.
